Internal Assessment Report

Client:	Water Authority	Reference	
Scheme:	Water Main Investigations	WPS2015	
Location:	Road One, Junction One	OS Reference	
Detail:	CCTV AND ACCOUSTIC INSPECTION	N/K	N/K
Asset Ref:	WPS- Mar002	Assessment Date:	
WPS Team Leader	D Poyntz	26/03/2015

Survey Comments:

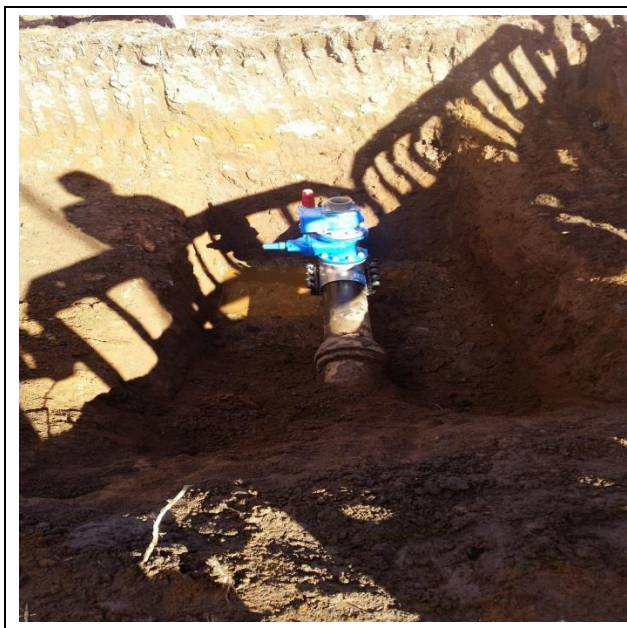
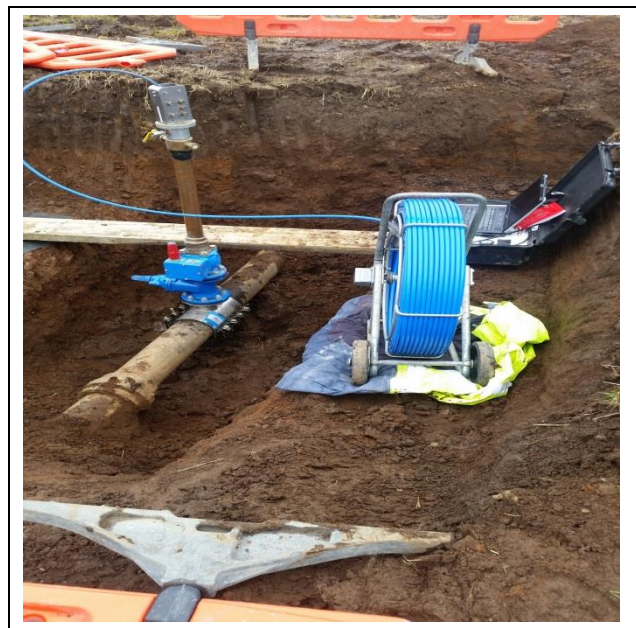
Site Photos

- Location in field of Road One
- Excavation safely barriered off
- Main drilled and tapped
- 100m Investigator system used due to low flow in pipeline
- System fully chlorinated prior to entry
- Blank plate fitted after inspection

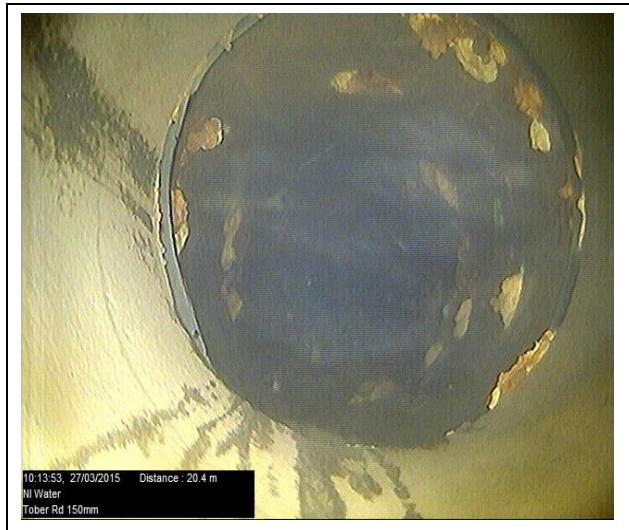
Title 1

- TITLE ONE. LARGE PIPE JOINT 20.4 METRES
- TITLE TWO. LATERAL IDENTIFIED 20.4 METRES
- TITLE THREE. LATERAL IDENTIFIED 20.1 METRES
- TITLE FOUR. VALVE IDENTIFIED 19.5 METRES
- TITLE FIVE. MAIN SHOT WITH TUBERCULATION GROWTHS ON PIPE WALL 19.3 METRES
- TITLE SIX. MAIN SHOT WITH TUBERCULATION GROWTHS ON PIPE WALL 17.2 METRES
- TITLE SEVEN. MAIN SHOT WITH TUBERCULATION GROWTHS ON PIPE WALL 14.5 METRES
- TITLE EIGHT. LATERAL IDENTIFIED 12.2 METRES

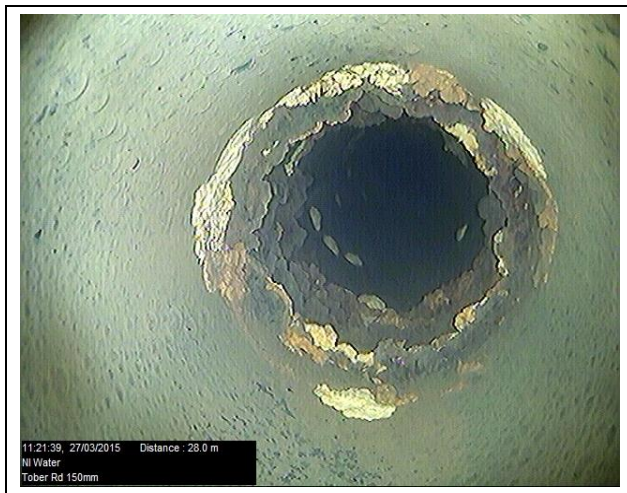
Title 9

- 29.4m Achieved, Large Tuberculation On Pipe Joint Halted Survey As System Could Not Navigate Past It
- 29.4m 00.10mins Large Pipe Joint
- 25.0m 01.07mins Clean Section Of Pipe

- TITLE NINE. PIPE JOINT WITH HEAVY TUBERCULATION 28.0 METRES
- TITLE TEN. MAIN SHOT 25.0 METRES
- TITLE ELEVEN. MAIN SHOT 19.1 METRES
- TITLE TWELVE. MAIN SHOT 18.9 METRES
- TITLE THIRTEEN. WALL SHOT WITH TUBERCULATION GROWTHS 16.6 METRES
- TITLE FOURTEEN. MAIN SHOT 14.2 METRES
- TITLE FIFTEEN. MAIN SHOT 13.4 METRES
- TITLE SIXTEEN. PIPE JOINT WITH HEAVY TUBERCULATION 4.0 METRES
